5.7 Reach 5

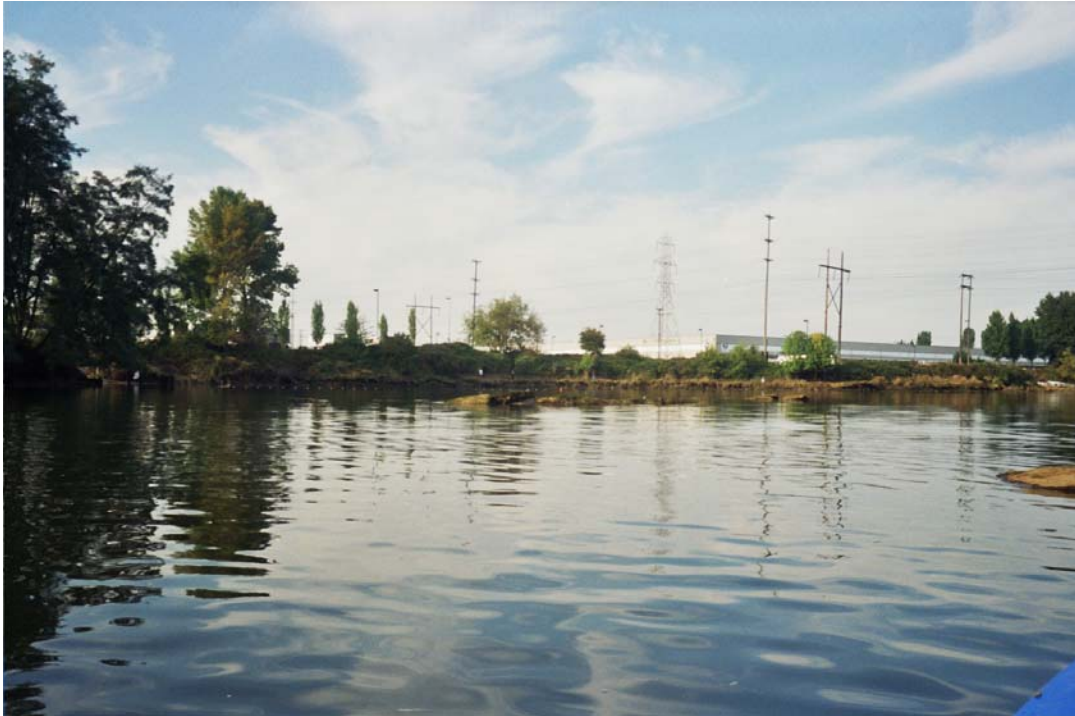
Photo 5-15. Fishing Nets at Reach 5, Station 27 of the Lower Green River.

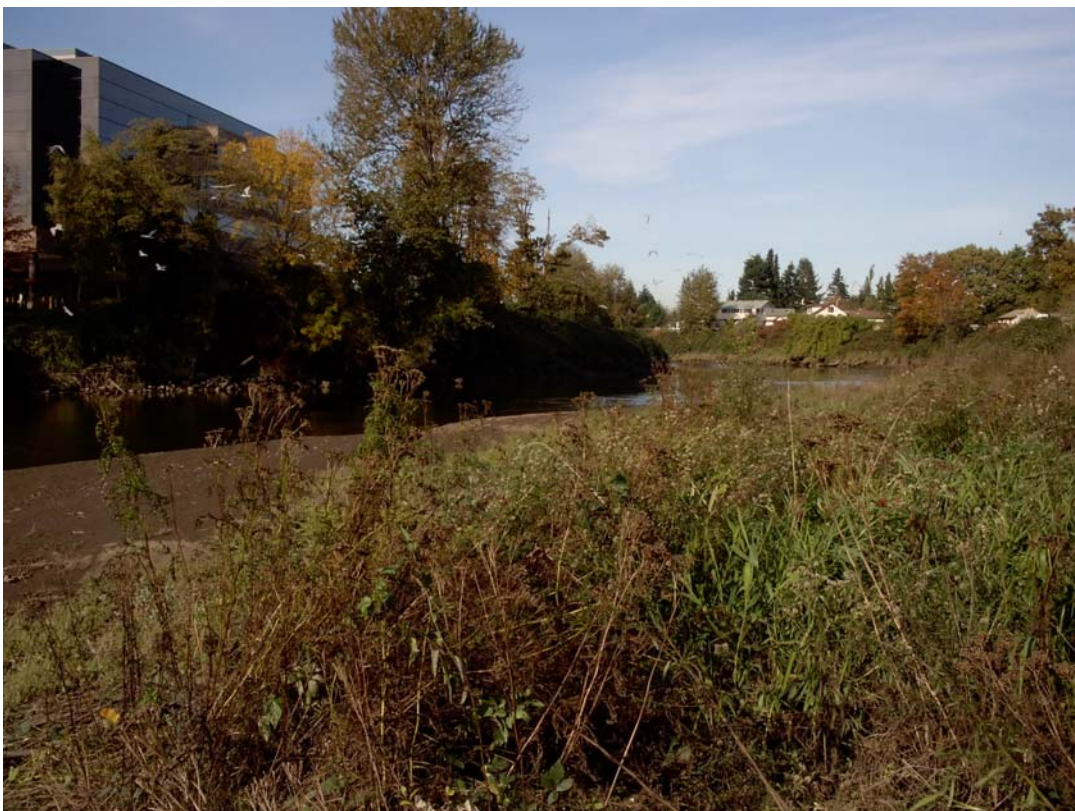
Photo 5-16. Salt marsh and mud flat at low tide on an inside bend in Reach 5, Station 15 of the Lower Green River.

Figure 5-31 shows the typical vegetative characteristics in Reach 5. Overhanging vegetation ranged from 0 to 50 percent, with a median overhang for the reach of 2 percent. Overall, vegetation in Reach 5 was of low to medium quality and dominated by invasive vegetation. In addition, the reach contains several unvegetated mudflats and patches of low and high salt marsh (Photo 5-16). The median canopy cover was 44 percent.

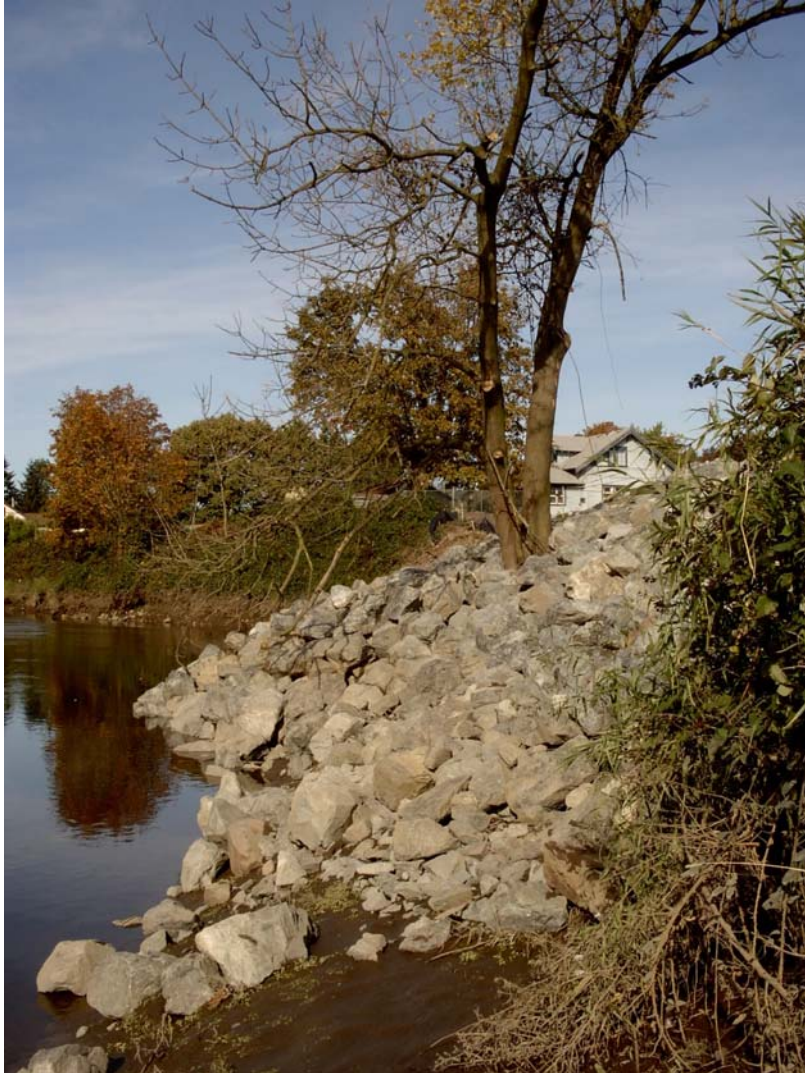
Photo 5-17. New riprap at a U.S. Army Corps of Engineers habitat restoration project on the right bank in Reach 5, Station 15 of the Lower Green River.

riprap was the dominant armoring type (Photo 5-17). A tire revetment is located at Station 25 (Photo 5-18). Two potential restoration opportunities were identified in Reach 5 (Figure 5-35). One opportunity at RM 8.3 would be to remove an invasive, non-native species of bamboo that grows along the right bank. The other potential restoration opportunity is to remove invasive vegetation and restore the understory vegetation on both banks between RM 7.15 and 7.95.

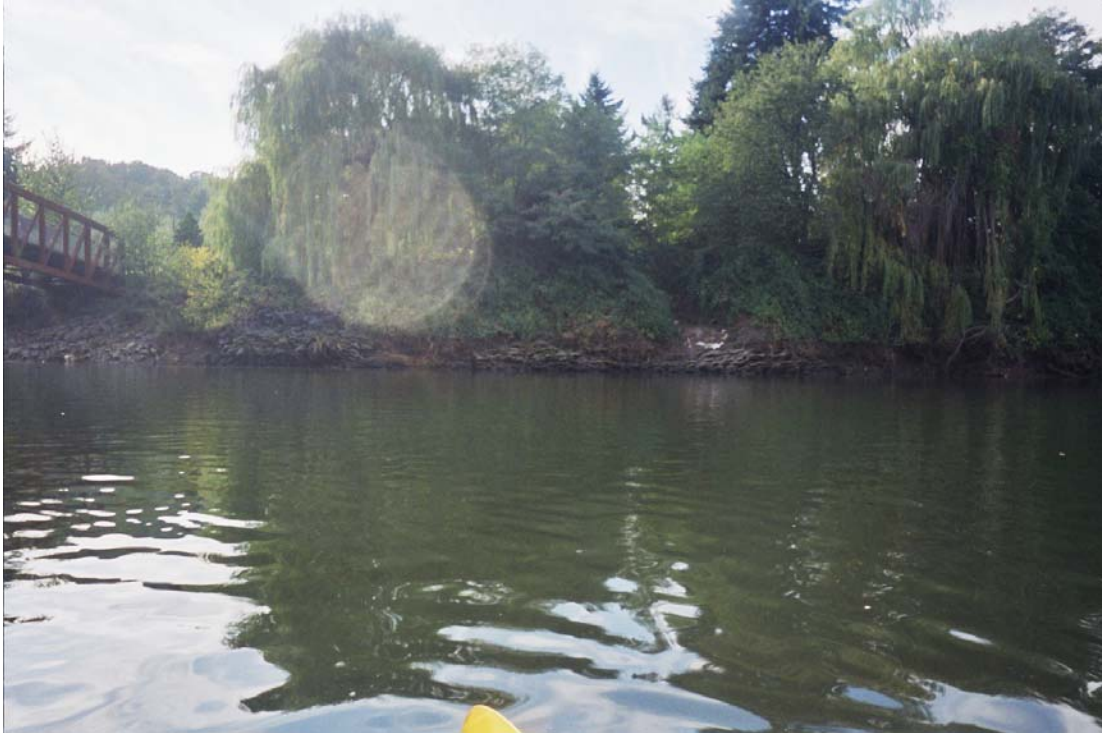
Photo 5-18. Tire revetment (background) on the left bank in Reach 5, Station 25 of the Lower Green River.
